CASE STUDY

TANK FAILURE ANALYSIS

EIS

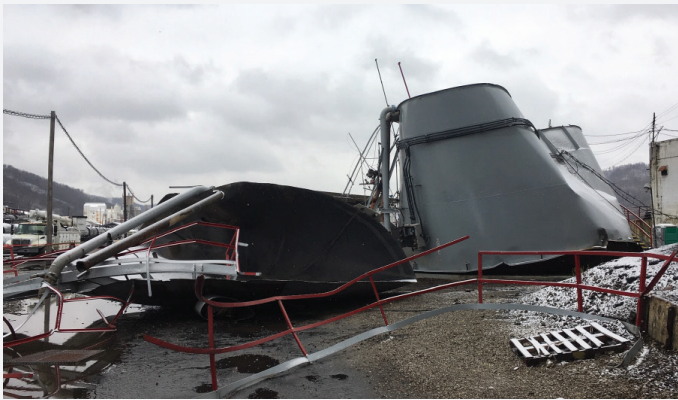
A Cavity Water Collection Tank sustained substantial damage. The roof had become completely detached and its shell to floor joint was broken at several locations. All anchor bolts were either pulled from foundation or broken. Plastic deformation was seen throughout the shell and floor, and buckling was observed in sections of the roof near the roof to shell joint. EIS was tasked to determine if overpressure or deflagration was responsible and identify the root cause.

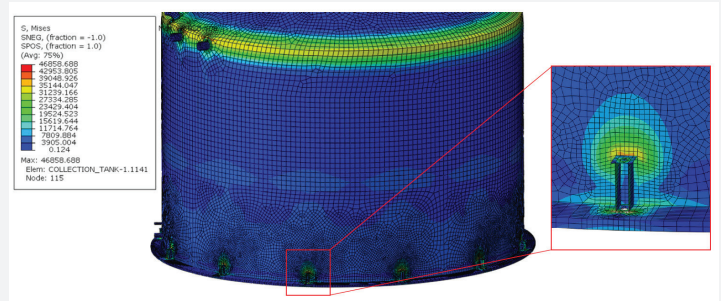
- ▶ Model predicted anchor bolts to fail first. Assuming 1.25"-7 bolts (0.969 in tensile area) with a yield strength of 55 ksi (per ASTM F1554 Gr. 55), maximum tensile load of 53,300 lbs can be achieved before yielding.
- ▶ The FEM showed that the tensile force in the bolt approached this value as internal pressure reached ~4.6 psig.

Figure shows a stress contour plot of the tank at ~4.4 psig.

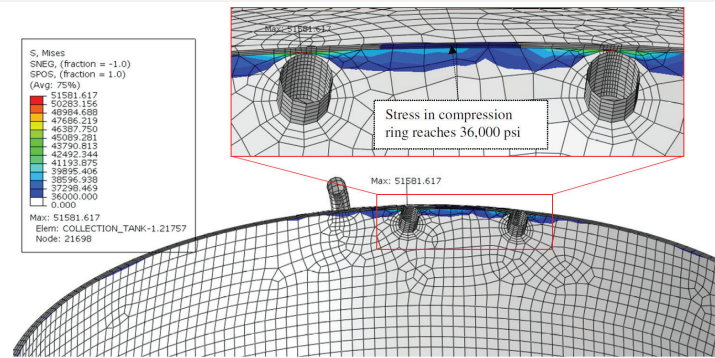
Figure shows the Von Mises stress at roof joint when ~6.5 psig internal pressure was applied. All areas reporting a stress less than 36,000 psi are shown in gray.

- ▶ The floor and floor joint were found to fail at almost the same time as the anchor bolts. Failure pressure ~4.6 psig.
- ▶ Failure not seen at roof joint until internal pressure reached ~6.5 psig.
- ▶ Yielding seen in shell at pressure slightly below this value, but API 650 and test data show roof failure occurs once compression ring yields.
- ▶ Buckling observed around roof joint once internal pressure reached ~8.0 psig.

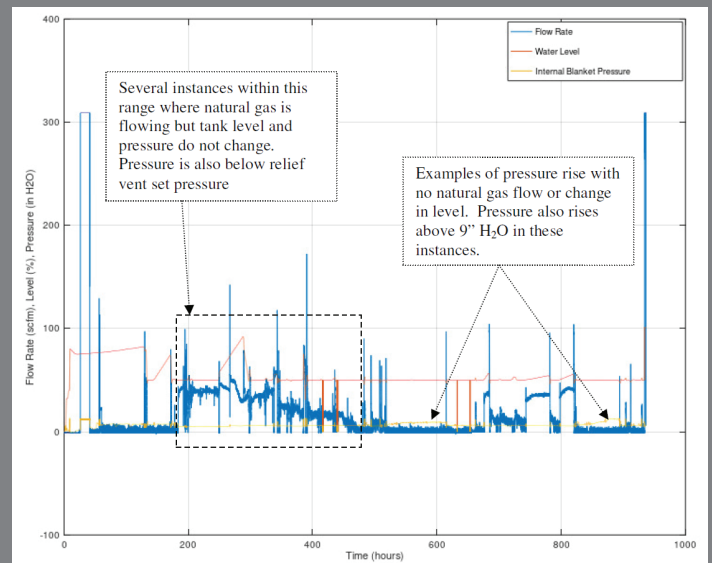
Figure shows additional observations that may not have caused the failure but appear as anomalies.
