TOWER STRESS & STABILITY ANALYSIS

CASE STUDY

Tower Stress and Stability Analysis

An EIS client was scheduled to replace a 654,515 lb and 160 ft tall tower during a turnaround and was concerned about its structural integrity during the lift. Corrosion had reduced the wall thickness at several locations, and years of operation had caused the tower to deform and accumulate additional weight. EIS was requested to complete a Finite Element Analysis (FEA) in order to safely perform the lift.

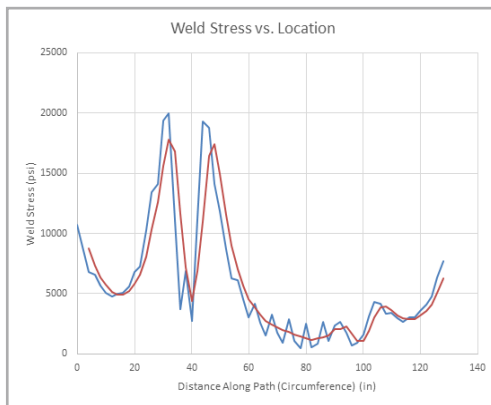
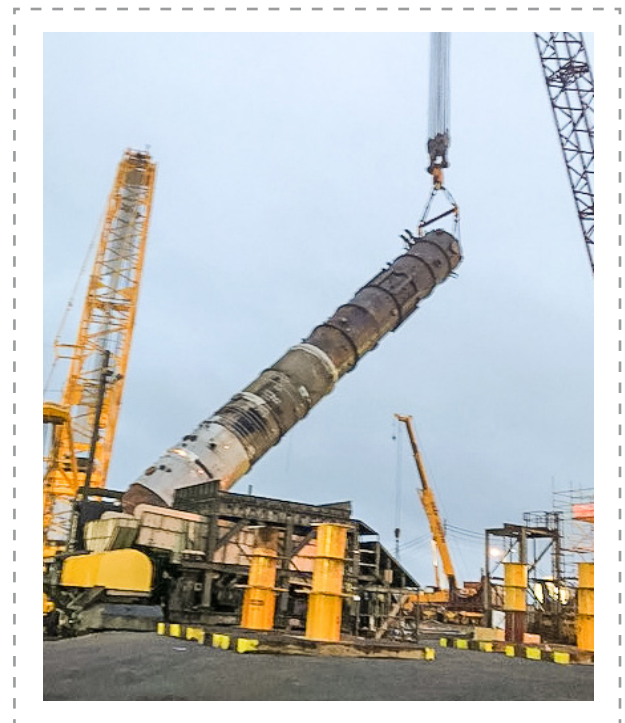
HORIZONTAL ORIENTATION

- Type 3 analysis converged up to a load factor of 2.28.
- Plastic strain contour plot shown below. All areas with virtually no plastic strain shown in gray.

PLOT OF WELD STRESS ALONG BEAM EDGE

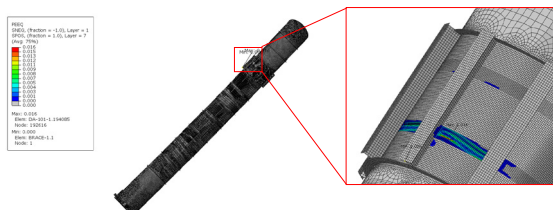
45° ORIENTATION

- Converged up to a load factor of 3.15.
- Analysis was terminated at this point since load factor of 2.28 had been exceeded.

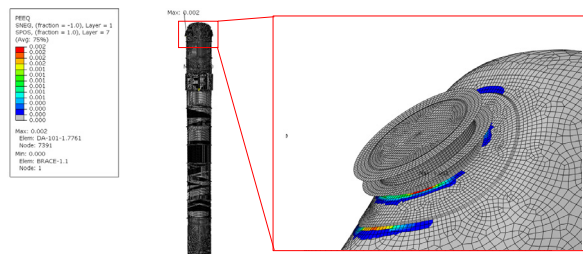
VERTICAL ORIENTATION

- Only global collapse analysis was done since all areas were in tension. Checked configuration where tower was supported by trunnions only and when a load is placed on the tail lug to begin rotation.
- Both converged to a load factor of 3.0.
