CASE STUDY

TOWER STRESS & STABILITY ANALYSIS

OVERVIEW

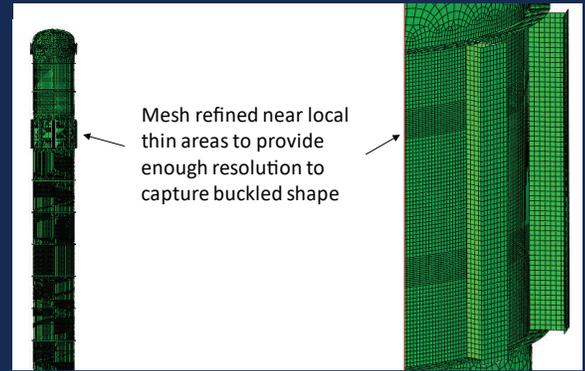
MODEL & MODIFICATION REQUIREMENTS

- ▶ ABAQUS finite element software used for FEA.
- ▶ Model was refined in critical areas to capture accurate stresses and buckling mode shapes.
- ▶ Vessel modeled using material properties of SA-285 Gr. C.
- ▶ Braces modeled using material properties of A-572 Gr. 50.
- ▶ 10-WT15X105.5 beams were added to stiffen local thin areas.
- ▶ Reinforcement plates were added to reinforce tail lug.

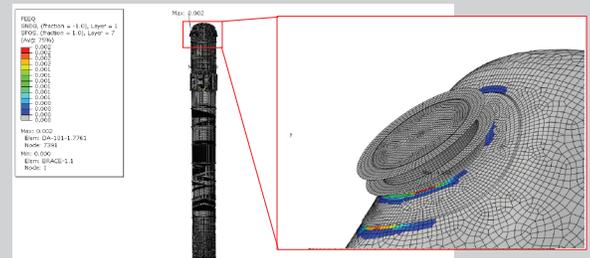
VERTICAL ORIENTATION

Only global collapse analysis was done since all areas were in tension. Checked configuration where tower was supported by trunnions only and when a load is placed on the tail lug to begin rotation. Both converged to a load factor of 3.0.

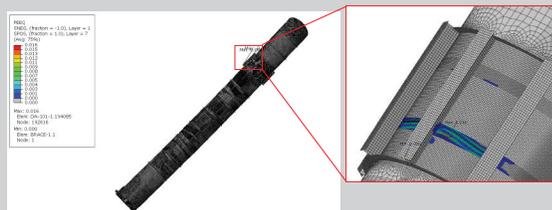
45° ORIENTATION

Converged up to a load factor of 3.15. Analysis was terminated at this point since load factor of 2.28 had been exceeded.
