TANK FAILURE ANALYSIS CASE STUDY

Cavity Water Collection Tank Failure

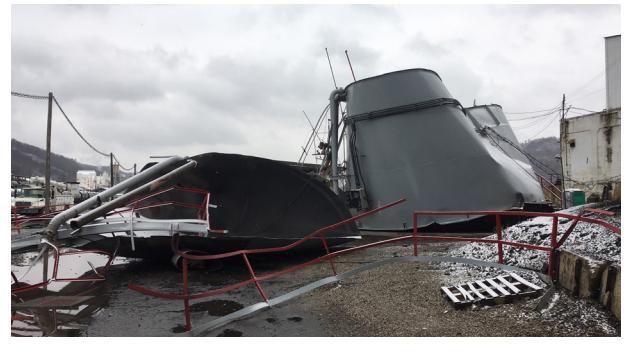
Tank sustained substantial damage. Roof had become completely detached and shell to floor joint was broken at several locations. All anchor bolts were either pulled from foundation or broken. Plastic deformation was seen throughout the shell and floor and buckling was observed in sections of the roof near the roof to shell joint. Goal for EIS was to determine if overpressure or deflagration was responsible and identify root cause.

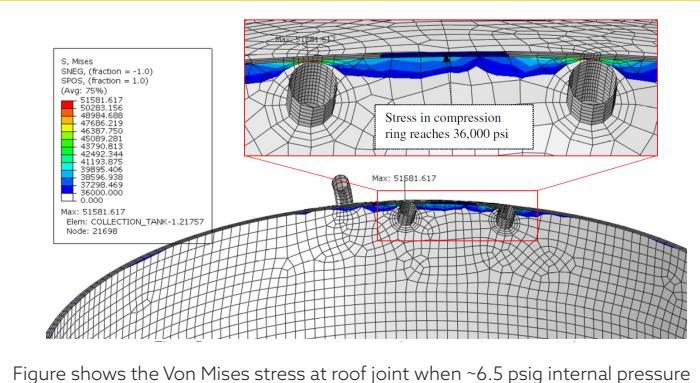
- Model predicted anchor bolts to fail first. Assuming 1.25"-7 bolts (0.969 in2 tensile area) with a yield strength of 55 ksi (per ASTM F1554 Gr. 55), maximum tensile load of 53,300 lbs can be achieved before yielding.
- The FEM showed that the tensile force in the bolt approached this value as internal pressure reached ~4.6 psig.

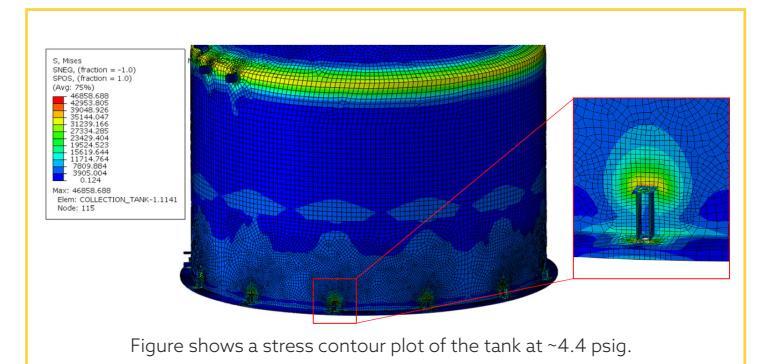
Figure shows the Von Mises stress at roof joint when ~6.5 psig internal pressure was applied. All areas reporting a stress less than 36,000 psi are shown in gray.

- The floor and floor joint were found to fail at almost the same time as the anchor bolts. Failure pressure ~4.6 psig.
- Failure not seen at roof joint until internal pressure reached ~6.5 psig.
- Yielding seen in shell at pressure slightly below this value, but API 650 and test data show roof failure occurs once compression ring yields.
- Buckling observed around roof joint once internal pressure reached ~8.0 psig.
