# CASE STUDY TOWER STRESS & STABILITY ANALYSIS

## OVERVIEW

An EIS client was scheduled to replace a 654,515 lb and 160 ft tall tower during a turnaround and was concerned about its structural integrity during the lift. Corrosion had reduced the wall thickness at several locations, and years of operation had caused the tower to deform and accumulate additional weight. EIS was requested to complete a Finite Element Analysis (FEA) in order to safely perform the lift.

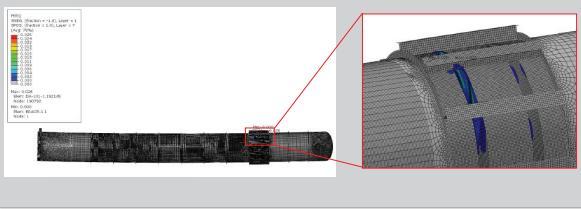
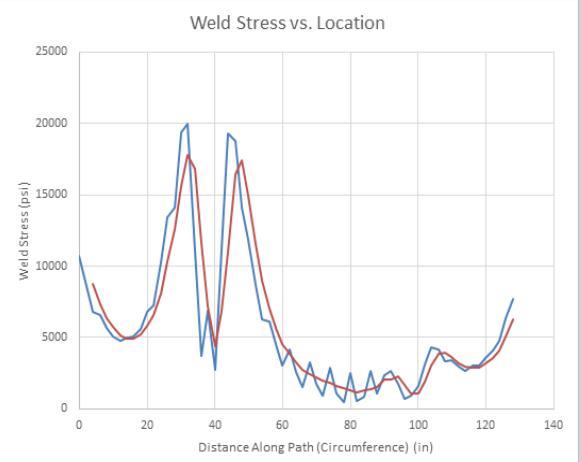
#### HORIZONTAL ORIENTATION

Type 3 analysis converged up to a load factor of 2.28. Plastic strain contour plot shown below. All areas with virtually no plastic strain shown in gray.

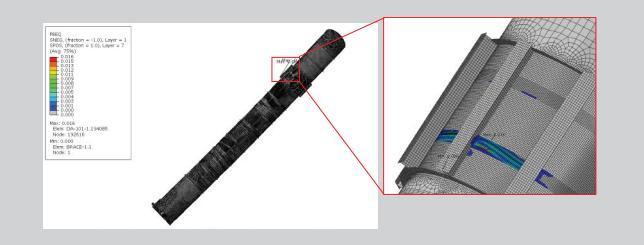
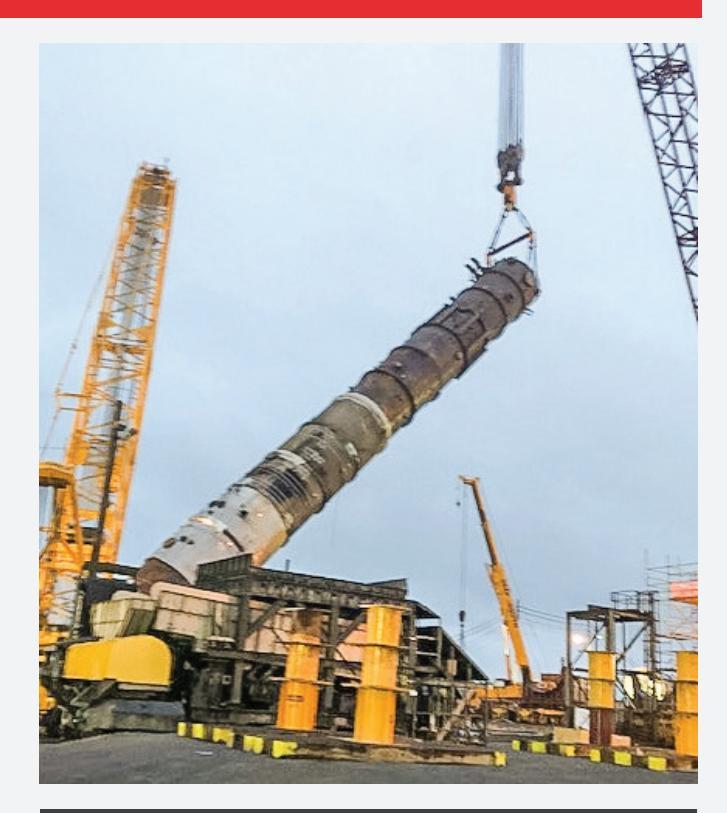
#### 45° ORIENTATION

Converged up to a load factor of 3.15. Analysis was terminated at this point since load factor of 2.28 had been exceededy.

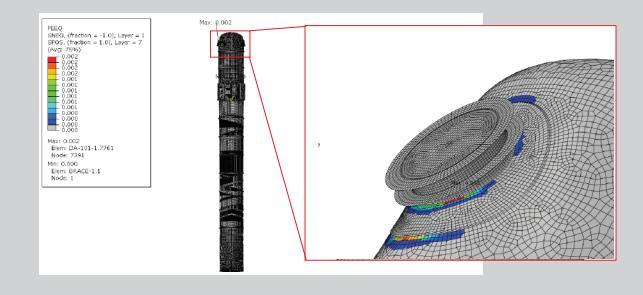
#### VERTICAL ORIENTATION

Only global collapse analysis was done since all areas were in tension. Checked configuration where tower was supported by trunnions only and when a load is placed on the tail lug to begin rotation. Both converged to a load factor of 3.0.
