TANK FAILURE ANALYSIS CASE STUDY

Cavity Water Collection Tank Failure

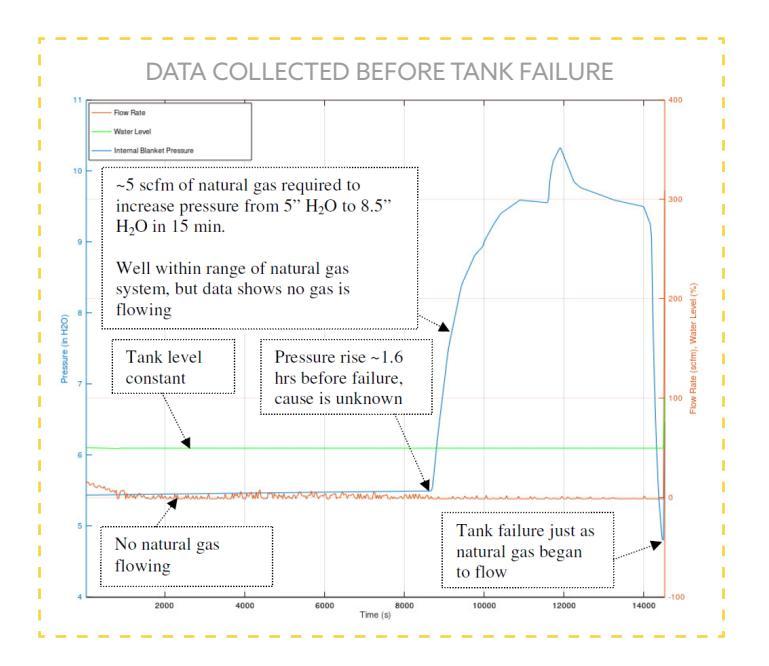
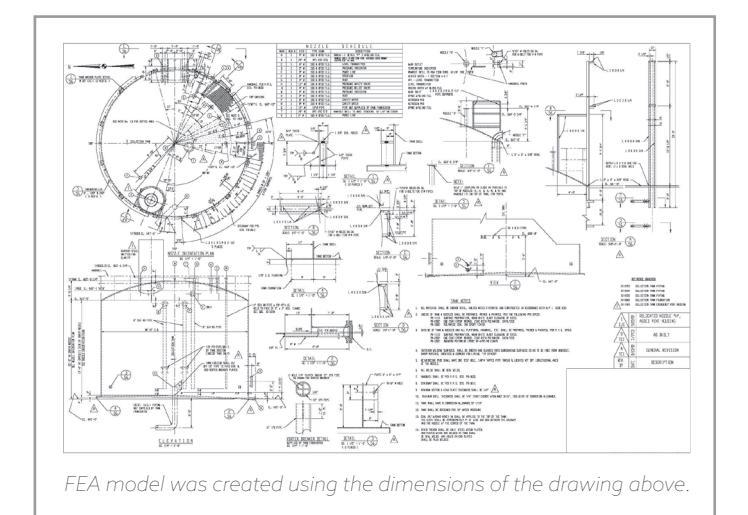
Tank sustained substantial damage. Roof had become completely detached and shell to floor joint was broken at several locations. All anchor bolts were either pulled from foundation or broken. Plastic deformation was seen throughout the shell and floor and buckling was observed in sections of the roof near the roof to shell joint. Goal for EIS was to determine if overpressure or deflagration was responsible and identify root cause.
