TOWER STRESS & STABILITY ANALYSIS

CASE STUDY

Tower Stress and Stability Analysis

An EIS client was scheduled to replace a 654,515 lb and 160 ft tall tower during a turnaround and was concerned about its structural integrity during the lift. Corrosion had reduced the wall thickness at several locations, and years of operation had caused the tower to deform and accumulate additional weight. EIS was requested to complete a Finite Element Analysis (FEA) in order to safely perform the lift.

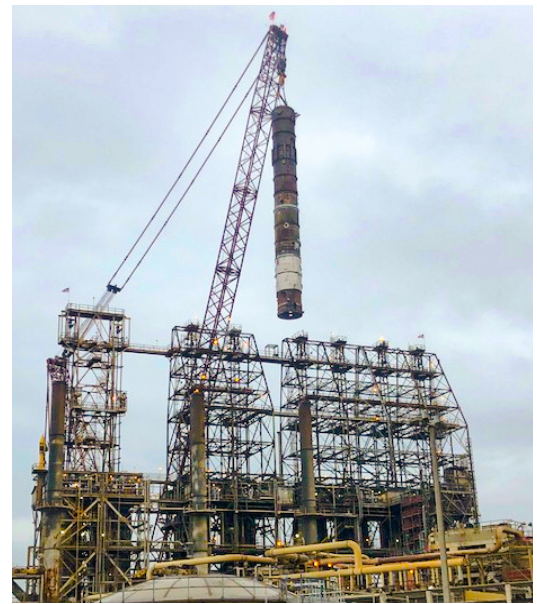
- 1 As EIS conducted the FEA, we found that local thin areas (LTAs) of the tower were becoming unstable. This meant it was failing to meet global collapse acceptance criteria and confirmed that the lift would be unsafe to perform.

- 3 With our results, we were able to calculate the appropriate size for support beams and determined that reinforcement plates should also be added on the outer surface of the skirt at the tail lug attachment points.
