# CASE STUDY TOWER STRESS & STABILITY ANALYSIS

## OVERVIEW

An EIS client was scheduled to replace a 654,515 lb and 160 ft tall tower during a turnaround and was concerned about its structural integrity during the lift. Corrosion had reduced the wall thickness at several locations, and years of operation had caused the tower to deform and accumulate additional weight. EIS was requested to complete a Finite Element Analysis (FEA) in order to safely perform the lift.

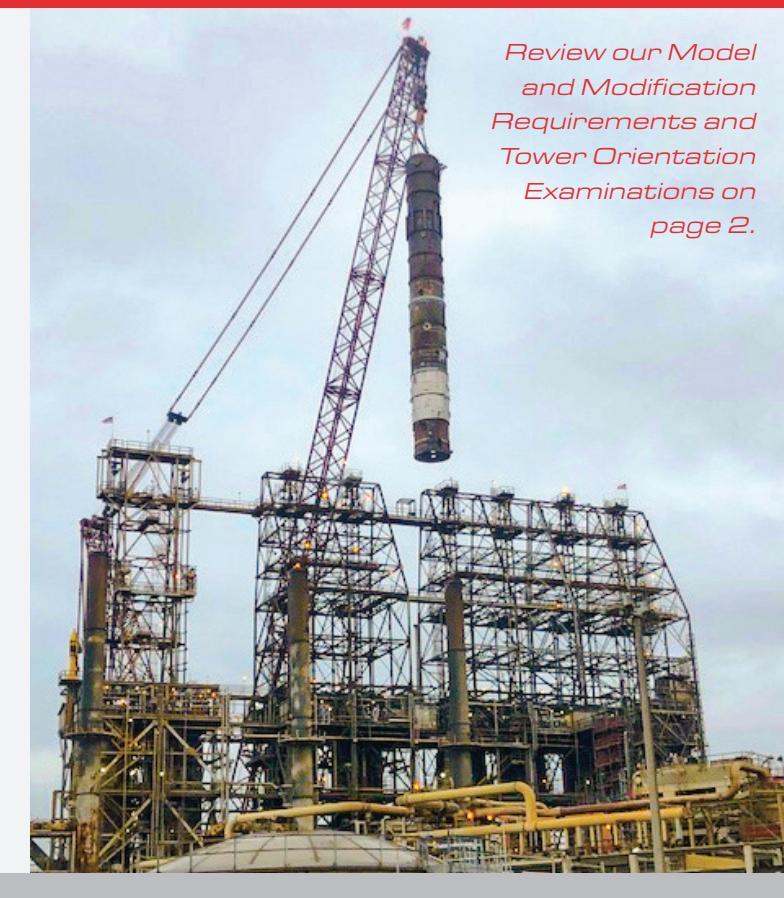
As EIS conducted the FEA, we found that local thin areas (LTAs) of the tower were becoming unstable. This meant it was failing to meet global collapse acceptance criteria and confirmed that the lift would be unsafe to perform.

EIS continued to conduct analyses on the requested tower orientations to find what modifications needed to be made. To find a solution that could capture load transfer to the beams, both collapse and buckling analyses were completed.

With our results, we were able to calculate the appropriate size for support beams and deteremined that reinforcement plates should also be added on the outer surface of the skirt at the tail lug attachment points.

After completion of our analyses, we supplied the client with the required modifications to safely perform the lift. The client was satisfied with the results, and the tower was successfully pulled and laid on its saddles.

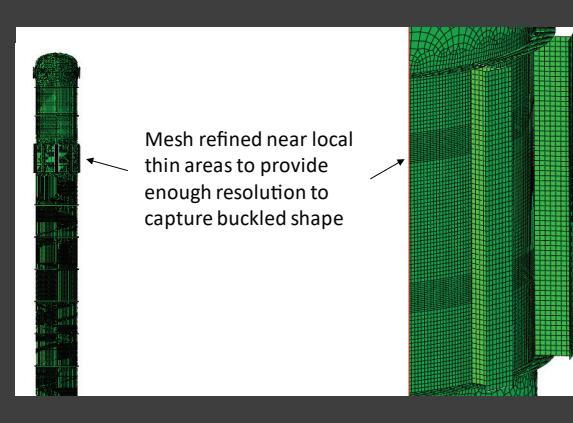
- ABAQUS finite element software used for FEA.
- Model was refined in critical areas to capture accurate stresses and buckling mode shapes.
- Vessel modeled using material properties of SA-285 Gr. C.
- Braces modeled using material properties of A-572 Gr. 50.
- 10-WT15X105.5 beams were added to stiffen local thin areas.
- Reinforcement plates were added to reinforce tail lug.
