CASE STUDY

TOWER STRESS & STABILITY ANALYSIS

OVERVIEW

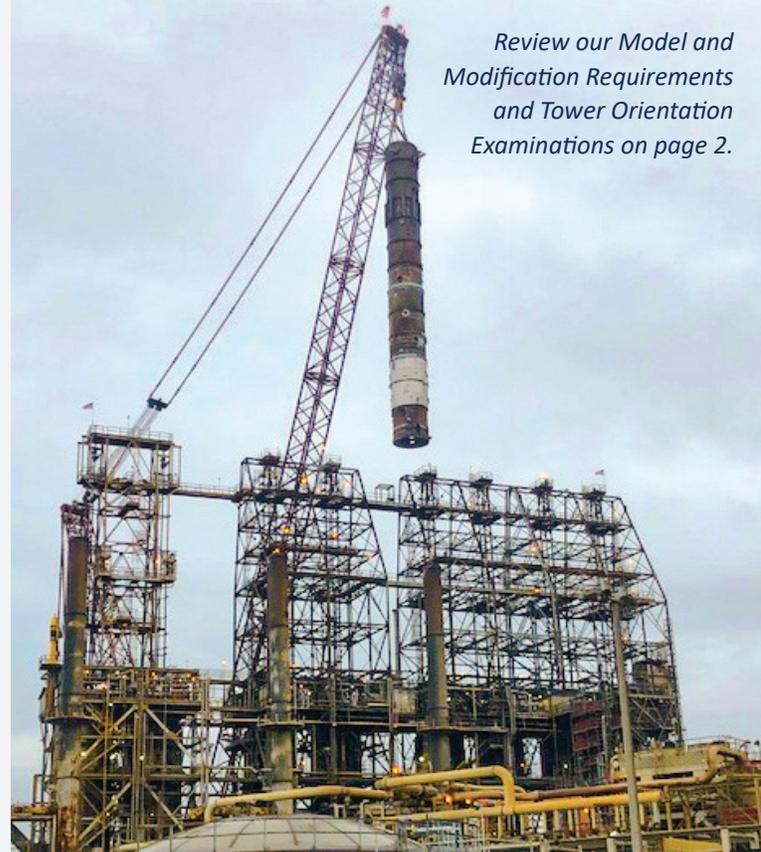
1 As EIS conducted the FEA, we found that local thin areas (LTAs) of the tower were becoming unstable. This meant it was failing to meet global collapse acceptance criteria and confirmed that the lift would be unsafe to perform.

2 EIS continued to conduct analyses on the requested tower orientations to find what modifications needed to be made. To find a solution that could capture load transfer to the beams, both collapse and buckling analyses were completed.

3 With our results, we were able to calculate the appropriate size for support beams and determined that reinforcement plates should also be added on the outer surface of the skirt at the tail lug attachment points.

4 After completion of our analyses, we supplied the client with the required modifications to safely perform the lift. The client was satisfied with the results, and the tower was successfully pulled and laid on its saddles.
